# Manhole Inspection Summary

Manhole # S31I\_\_032MH

Insp Date: **12/22/08 11:05 AM**

**Location** Address: **Dover St**

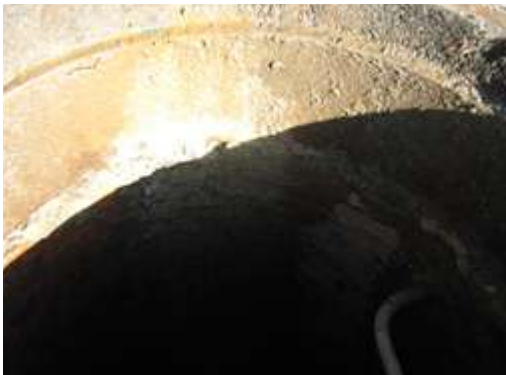
MISC

Condition: ☐ Sound ☐ Cracked ☒ **Leaks**

lid/frame infiltration

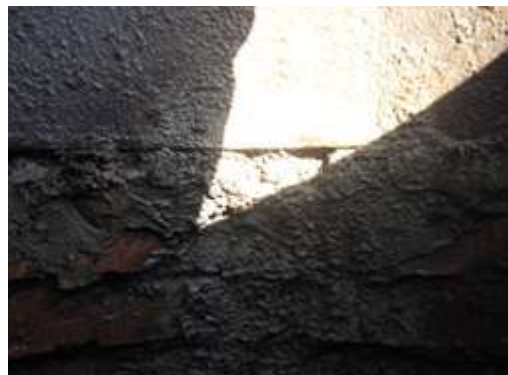
Defect 4

Condition: ☐ Sound ☐ Cracked ☐ Root Intrusion ☐ Loose Brick ☒ **Deteriorated**

Infiltration: ☐ None ☒ **Joint** ☐ Cracks ☐ Mortar ☐ Roots ☐ Wall

joint infiltration frame/chimney  
deteriorated

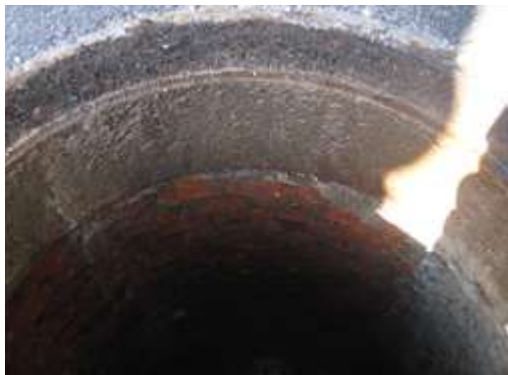
Defect 2

infiltration frame & chimney

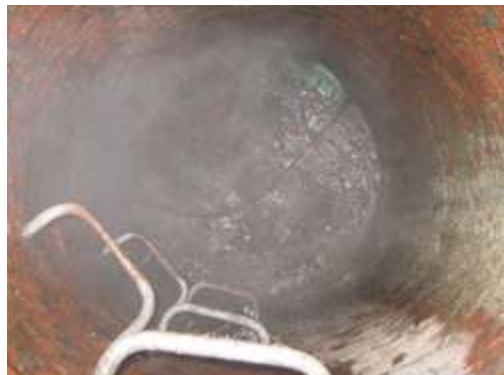
Defect 1

Infiltration: ☐ None ☐ Joint ☐ Cracks ☐ Mortar ☐ Roots ☒ **Wall**

Count: **7** Missing: **0** ☒ **Corroded**

corroded rungs, corbel infiltration debris  
on bench and channel

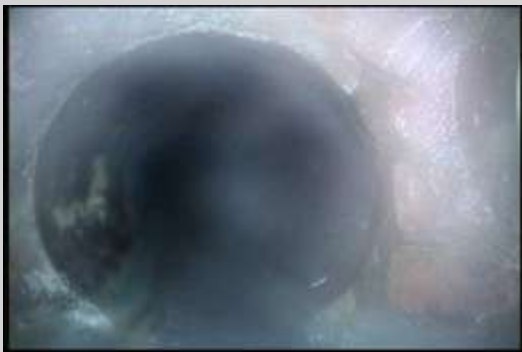
12 O'Clock Outflow

10 in. Circular Gravity Sewer  
Pipe Out @ 12 O'Clock

Pipe Height: **10.8** (in.) Rod and Bar (Angled)  
Pipe Material: **Clay** ☐ Pipe Lined  
Invert Depth: **10.06** (ft.) Flow Characteristics: **Fast**  
Deposits: ☒ None ☐ Mud ☐ Sludge ☐ Debris ☐ Grease  
Silt Depth: **0** (in.) Deposits Extent:  
Infiltration: **None** Pipe Seal Cond: **Sound**

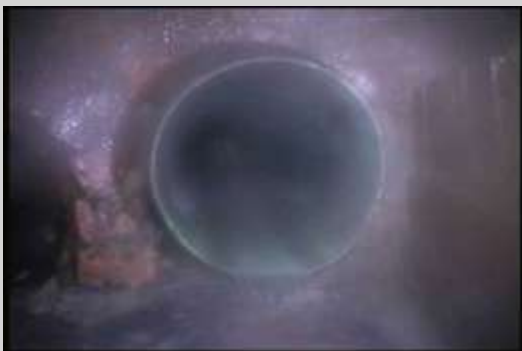
2 O'Clock Inflow

10 in. Circular Gravity Sewer  
Pipe In @ 2 O'Clock

Pipe Height: **10.8** (in.) Rod and Bar (Angled)  
Pipe Material: **PVC** ☐ Pipe Lined  
Invert Depth: **9.84** (ft.) Flow Characteristics: **Fast**  
Deposits: ☒ None ☐ Mud ☐ Sludge ☐ Debris ☐ Grease  
Silt Depth: **0** (in.) Deposits Extent:  
Infiltration: **None** Pipe Seal Cond: **Sound**

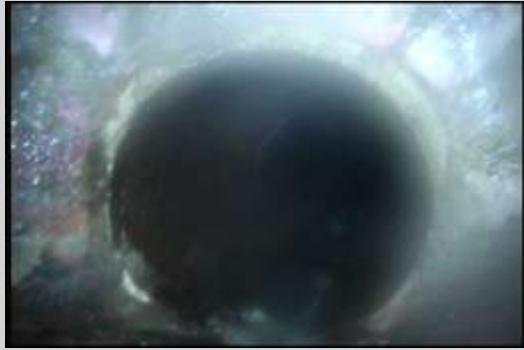
10 O'Clock Outflow

10 in. Circular Gravity Sewer  
Pipe Out @ 10 O'Clock

Pipe Height: **10.8** (in.) Rod and Bar (Angled)

Pipe Material: **Clay** ☐ Pipe Lined

Invert Depth: **10.46** (ft.) Flow Characteristics: **None**

Infiltration: **None** Pipe Seal Cond: **Sound**
